PROBABILITY OF DETECTION STUDY ON IMPACT DAMAGE TO HONEYCOMB COMPOSITE STRUCTURE USING THERMOGRAPHIC INSPECTION

Andrew J Hodge and James L Walker II
Damage Tolerance and Assessment Branch, Marshall Space Flight Center

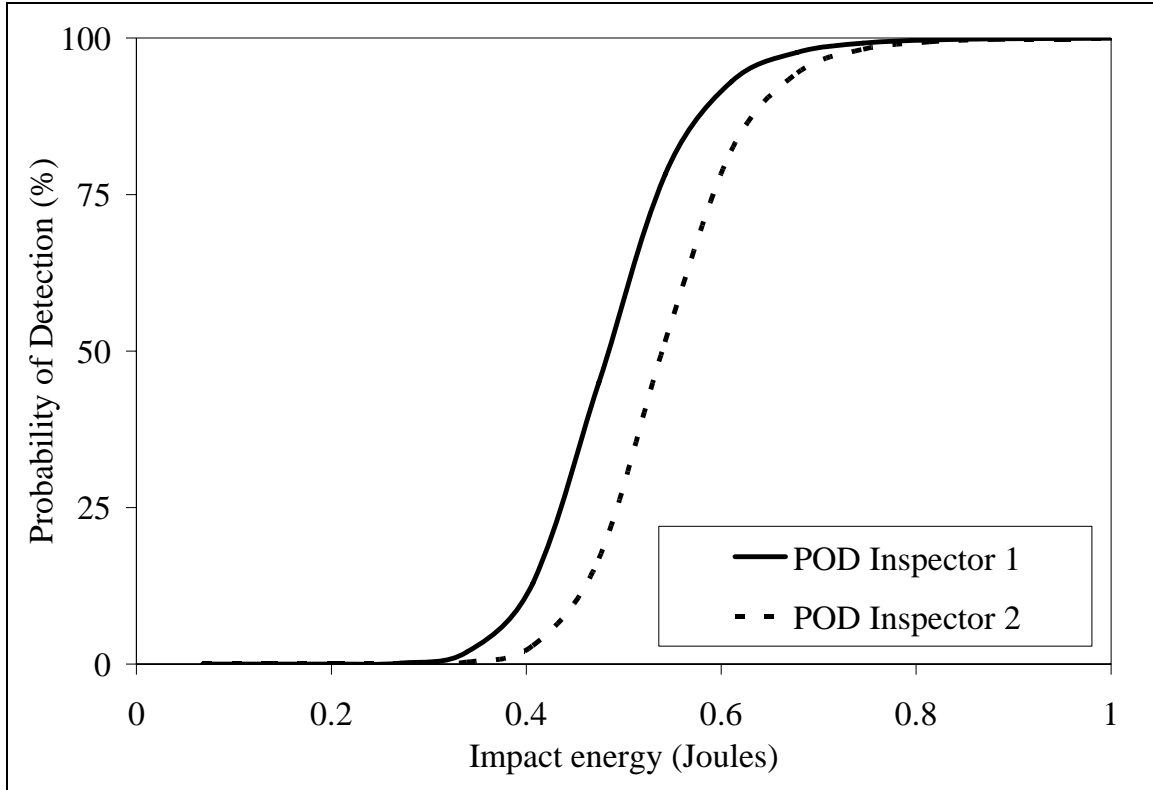
Figure 3. Probability of Detection for a Given Impact Energy

2.1 Thermographic Inspection. Following impact testing, two NDE technicians independently performed thermographic inspection on the intertank. Thermography was performed with a FLIR Pheonix with 25 mm lens using Thermal Wave Imaging software. None of the impacts of 0.4 Joules or smaller were detected, half of the impacts of 0.5 Joules were detected, and all impacts of 0.7 Joules or greater were detected. A 90/95 probability of detection for impact energy is 0.62 Joules (Figure 3). Figure 4 contains typical thermography images of indications at various impact sites.
